**BLUE  
SERIES**

*S799 Servo Bore Repair System:*

**AW55**

This tool is for use on **Aisin AW55-50SN, and AW55-51SN** transaxles.

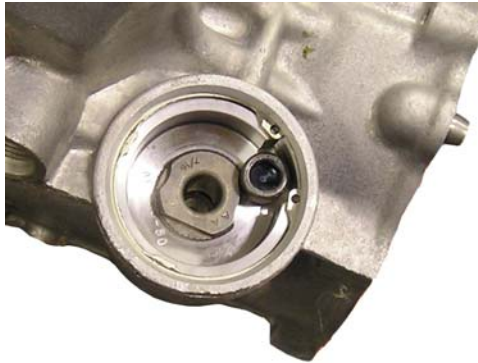
1. Install the drill jig into the case by setting the jig into the servo. Install the transmission's servo snap-ring above the jig.
2. Drop the 7/16" guide into the jig. It doesn't matter which one of the lands on the guide you use, as long as one of the lands is under the 3/8" Allen screw.
3. Ream out the bore using the 7/16" reamer, applying ample lubrication. \* **DO NOT REAM ABOVE 500 RPM.**
4. Replace the 7/16" reamer guide with the 1/2" guide, and the 7/16" reamer with the 1/2" reamer.
5. Ream the bore out using the 1/2" reamer with ample lubrication.\* Take care not to either push too hard on the reamer or turn the reamer faster than 500 RPM when reaming. Either one can overly enlarge the bore, causing a loose bushing.
6. Clean the case before proceeding to step number seven.

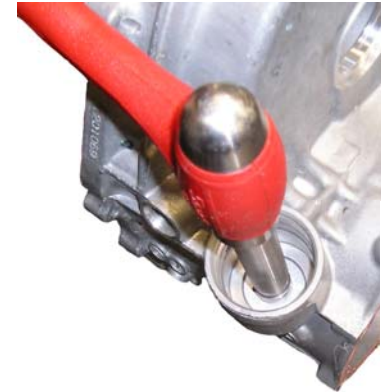
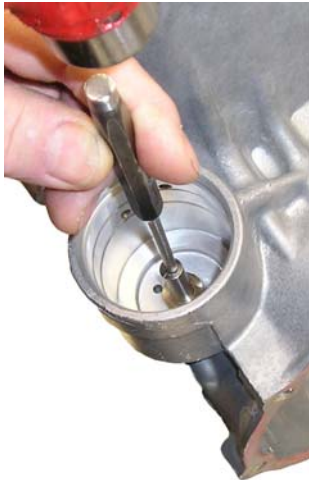
7. Apply Loctite® (preferably **green #680**) or equivalent to the bushing and drive the bushing in by hitting the driver until the bushing bottoms.

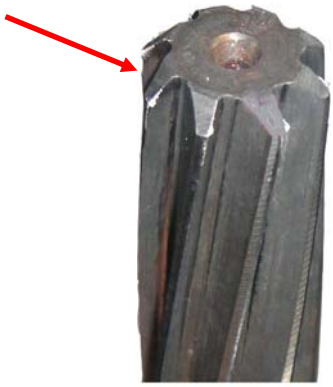
Inspect for aluminum buildups on the cutting edges as pictured left.

Reamers are like drills, if you use them repeatedly in aluminum they develop build-ups on the cutting edges. These build-ups effectively make the reamer larger, causing a larger hole. This larger hole then robs the bushing you're installing of interference needed to properly crush the bushing. This causes the pin to be loose in the bushing, which defeats the entire purpose. To prevent this, you need to (1) keep your reamers sharp and (2) use plenty of CUTTING OIL when reaming.
